Inspection Notice on the ISC Steel Swivel Karabiner

February 2018

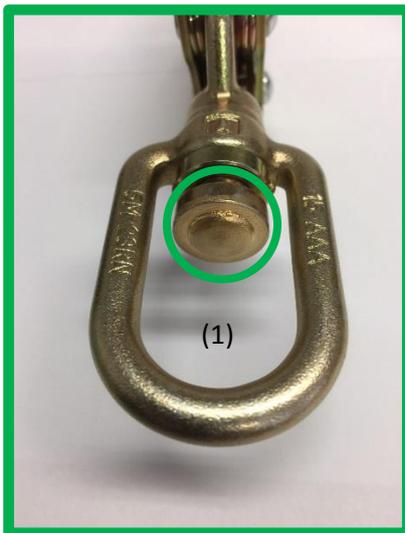
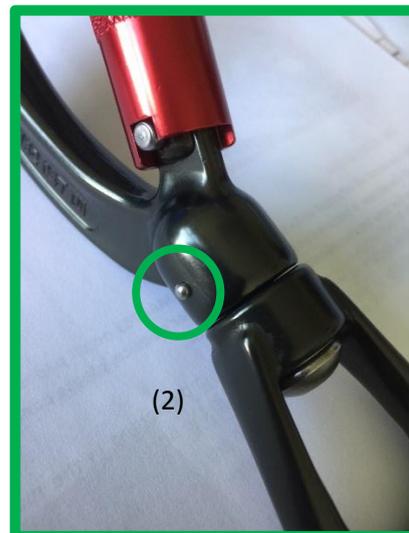
If the nut at the head of the karabiner is peened (1) or the screw through the head of the karabiner is captivated with a rivet through the body of the karabiner (2), as shown above, no further action is required at this time.

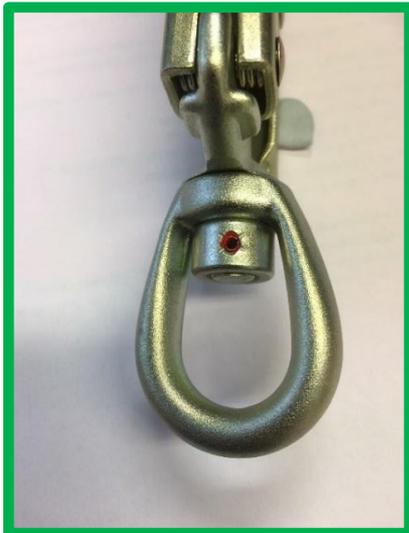
If the Karabiner has a roll-pin with red paint, please continue with the inspection in step 2.

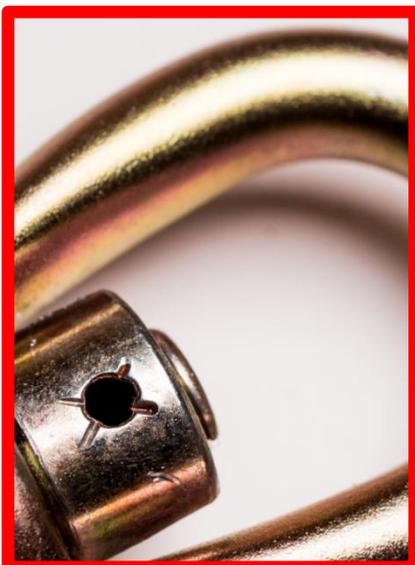
IMPORTANT: If you do not see the red paint or if there is no pin present or if the nut rotates or is loose the karabiner should be removed from service immediately – please return to the manufacturer in line with the corrective action at the end of this notice.

Please send all affected units back to ISC quoting RMA#763 on all paperwork and boxes. If the Steel Swivel Karabiner is installed on another manufacturer's device, please contact that manufacturer. We apologize for any inconvenience caused by this issue.

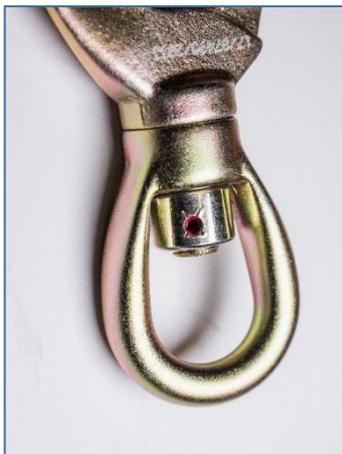
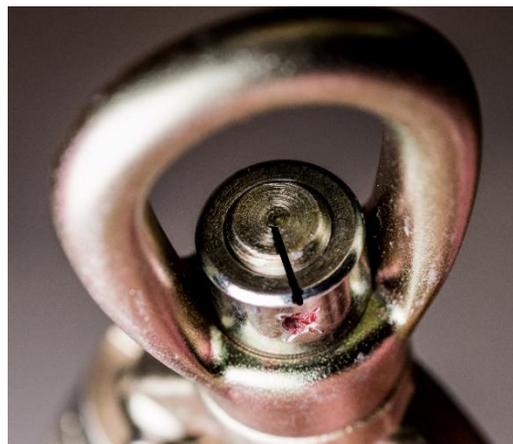
Step 2: Inspect the nut at the top of the Steel Swivel Karabiner. You should notice a hole in the nut where the retaining pin is inserted at the factory. Look for the red indicator paint which should be in the hole.

If you see the red indicator paint within the hole, please take the following steps to verify the swivel is secure during daily inspections:

- 1) Verify presence of the red paint and the roll-pin.
- 2) Customer should permanently mark the top of the stem and nut as shown below. During daily inspection verify that the mark remains aligned between the stem and nut and does not rotate.
